# Flood Modelling due to Dam Failure Using HEC-RAS 2D with GIS Overlay: Case Study of Karalloe Dam in South Sulawesi Province Indonesia

**Keywords** Flood Modelling, Dam Break, Synthetic Unit Hydrograph, HEC-RAS 2D

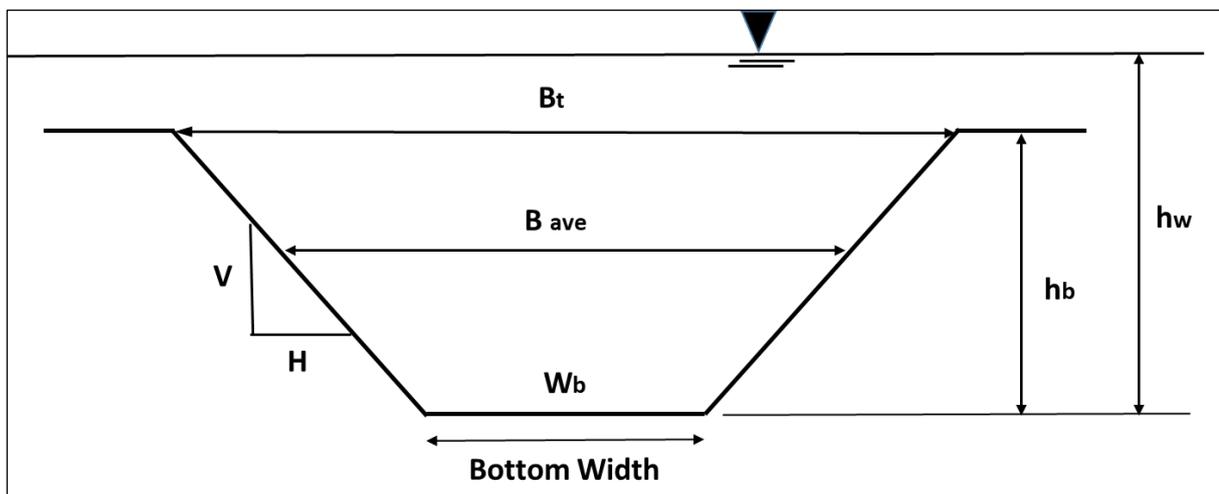
**Figure 1.** Fracture parameter overview

Fractures usually occur prior to the dam's total collapse (Figure 1). The following is Froehlich's [23] regression equation for average fracture width and failure time:

According to Froehlich [23], the mean side slope for overtopping failure should be horizontal to vertical (1:1).

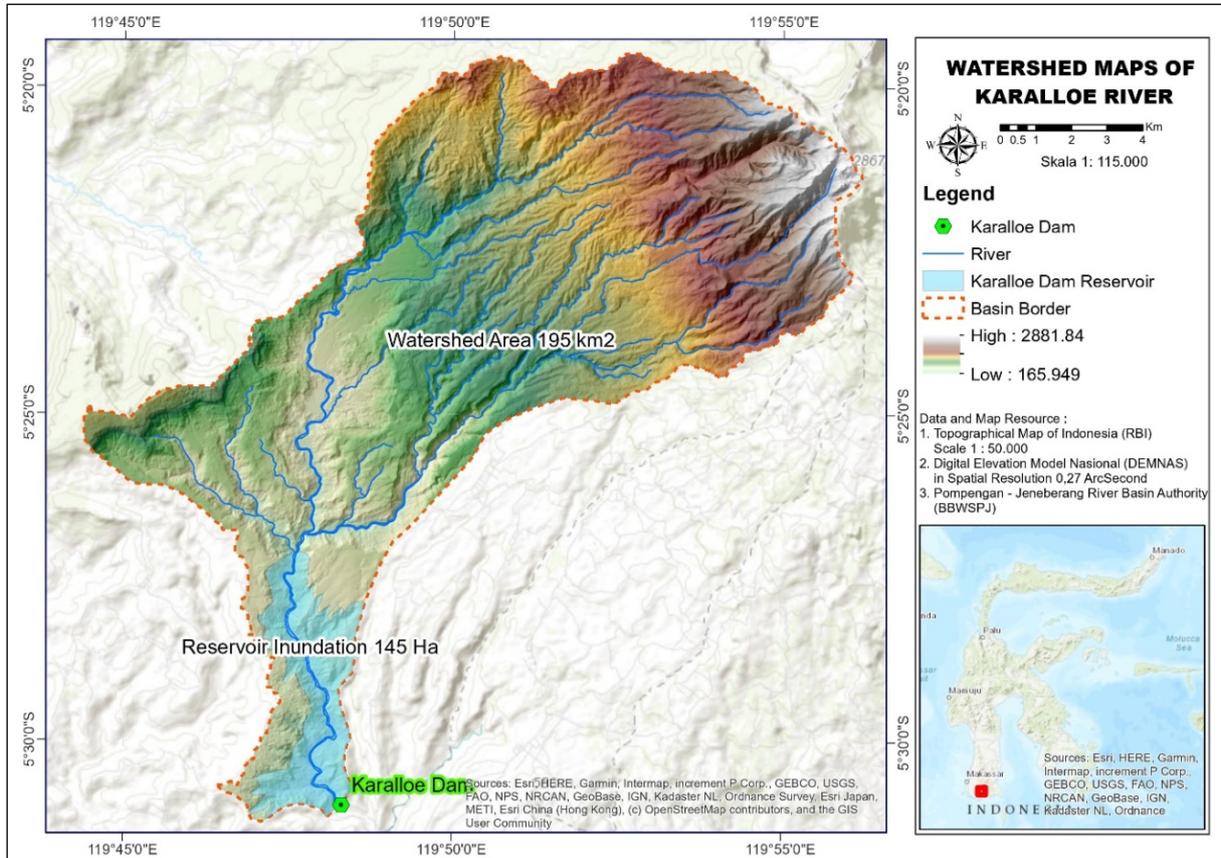
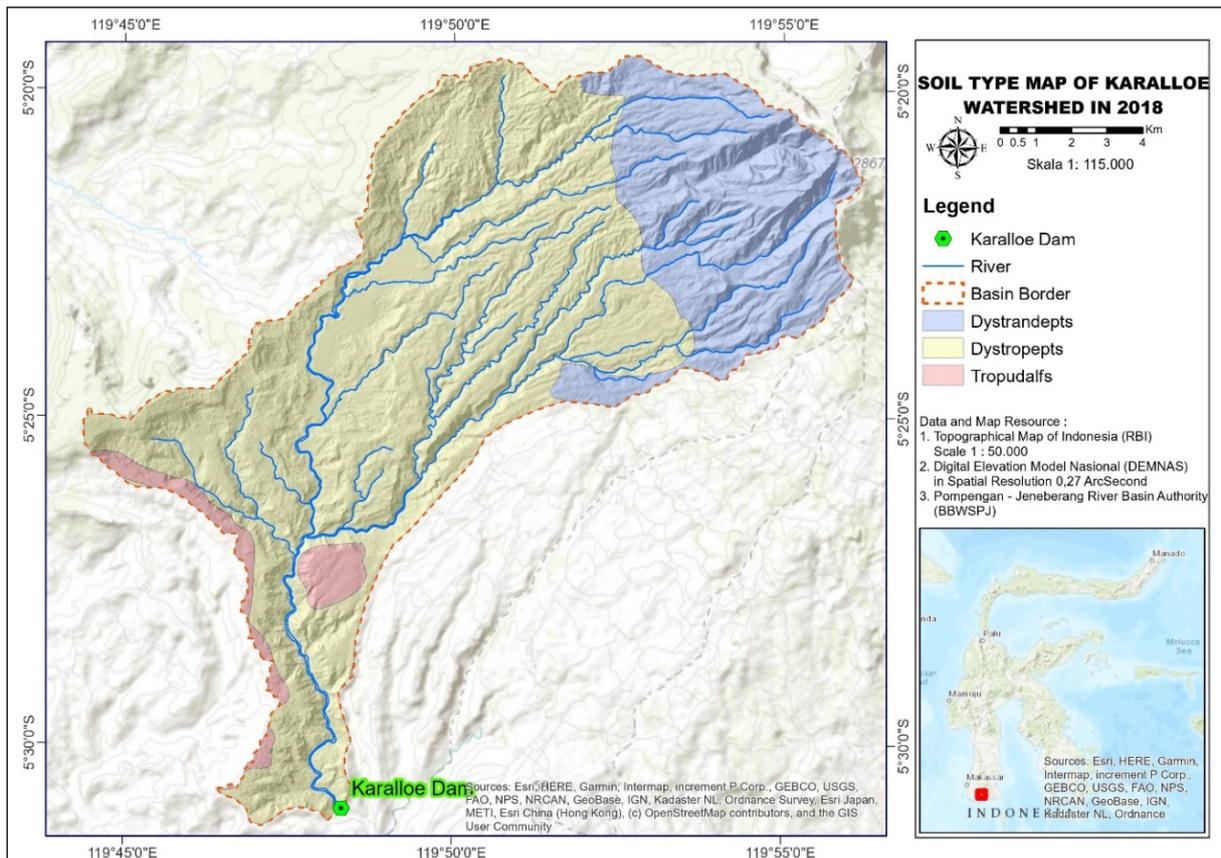
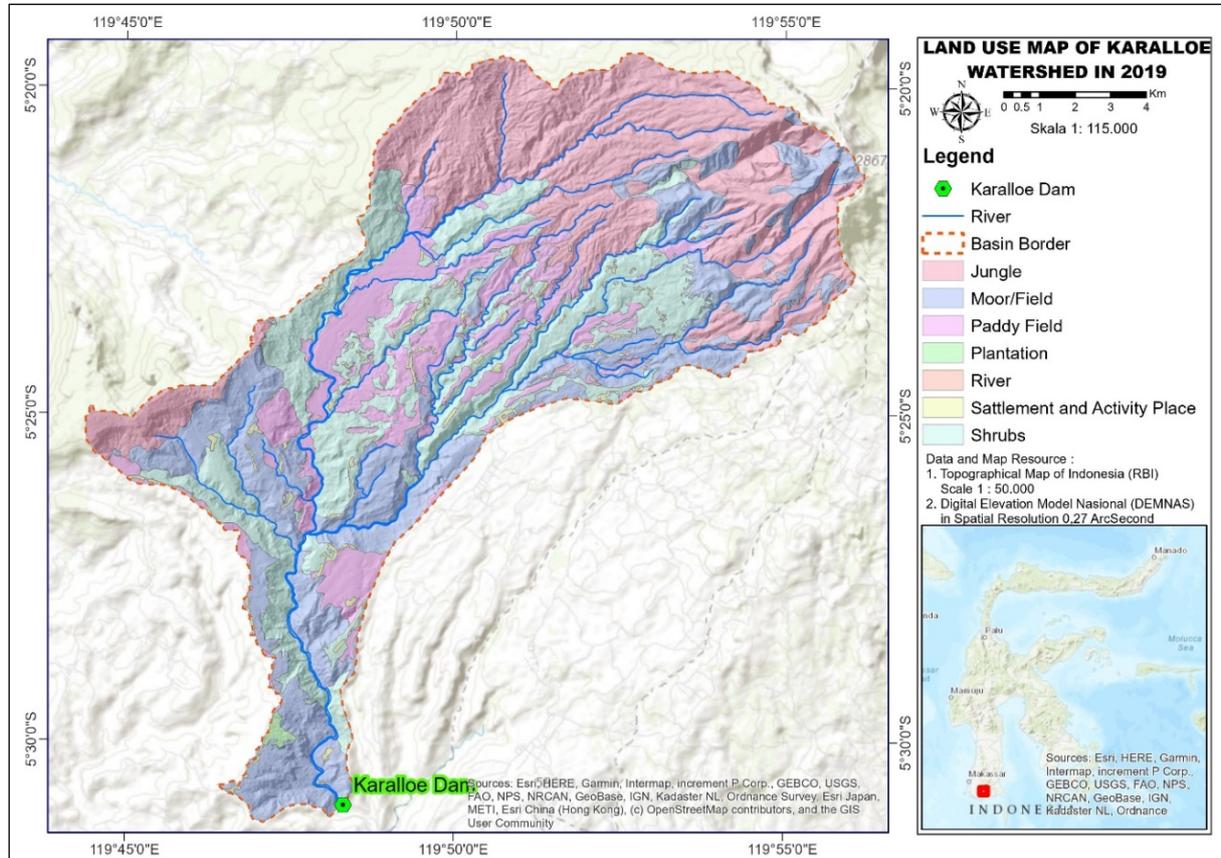
Figure 2. Map of Topographic, soil type and land use of the Karalloe Watershed

they significantly impact rainwater that will become surface runoff. The map in Figure 2 can describe the characteristics of the Kelara watershed.

The characteristics of the Karalloe watershed can be seen in Figure 2, which shows that the watershed area is 195.23 km<sup>2</sup>, the length of the main river is 27.27 km, the highest elevation is +848 masl, the lowest elevation is +165 masl, the average river slope is 0.026 percent, dystropepts dominate the soil type, and the land is dominated by forest. The input parameters for the HEC-HMS are derived from the results of the watershed characteristics analysis. Table 2 displays these parameters. Three TRMM posts collect rainfall data, which affects the Karalloe watershed. Figure 3 and Table 3 show the TRMM location and data.

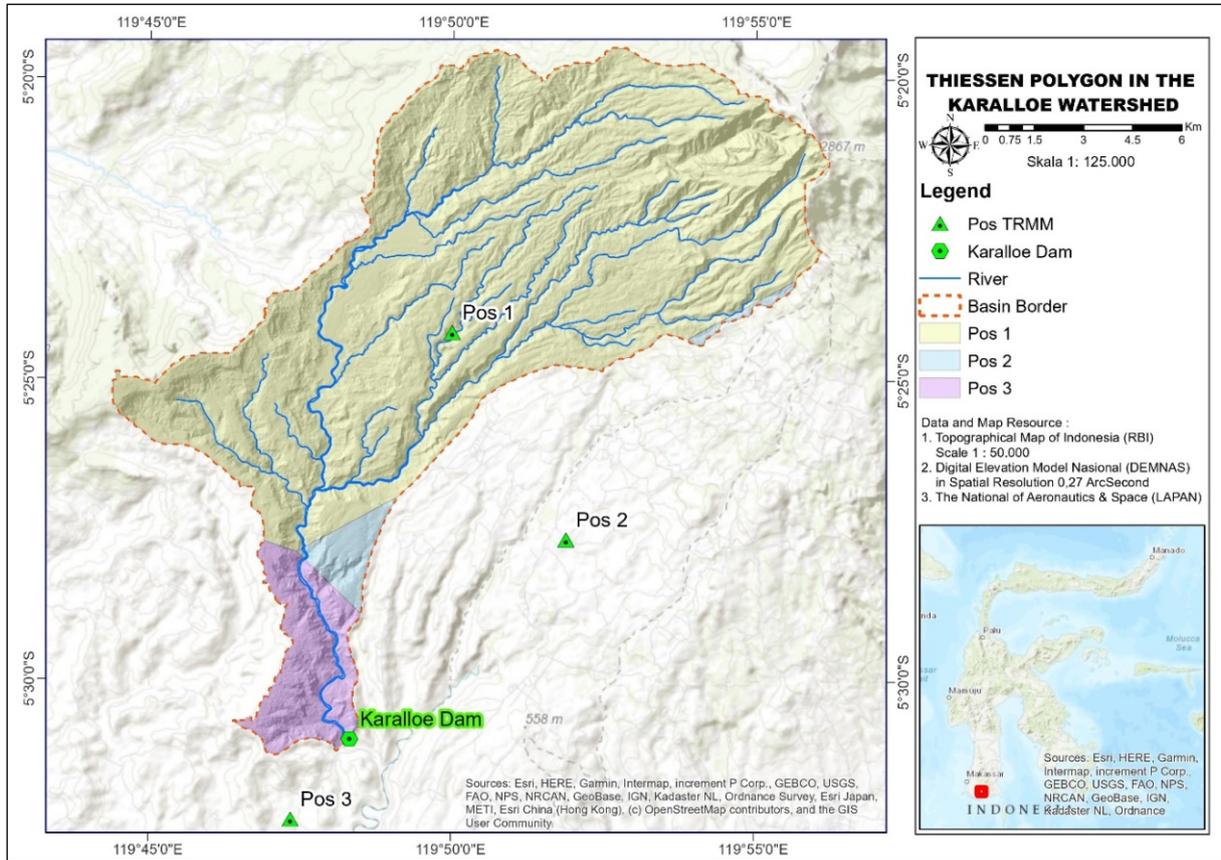
Figure 3. Thiessen polygon of the Karalloe watershed

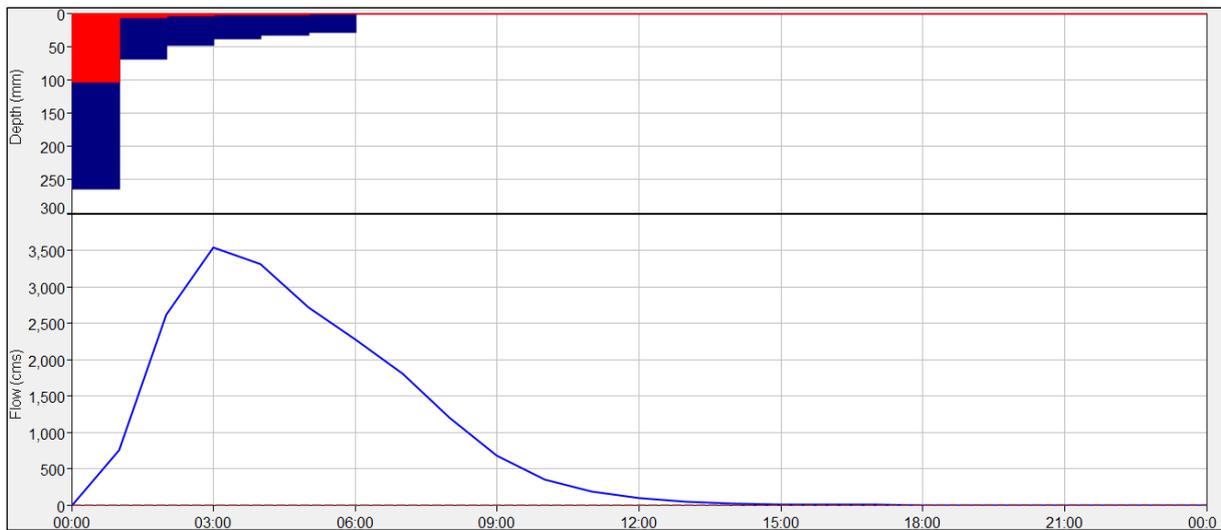
Figure 4. QPMF flood hydrograph of the Karalloe Watershed

The Probable Maximum Precipitation (PMP) analysis performed at the Karalloe Dam location yielded a value of 478.77 mm/day. In addition, a QPMF discharge analysis was performed using the HEC-HMS application, yielding a value of 3534.8 m<sup>3</sup>/sec. Figure 4 depicts the outcome of the QPMF discharge analysis.

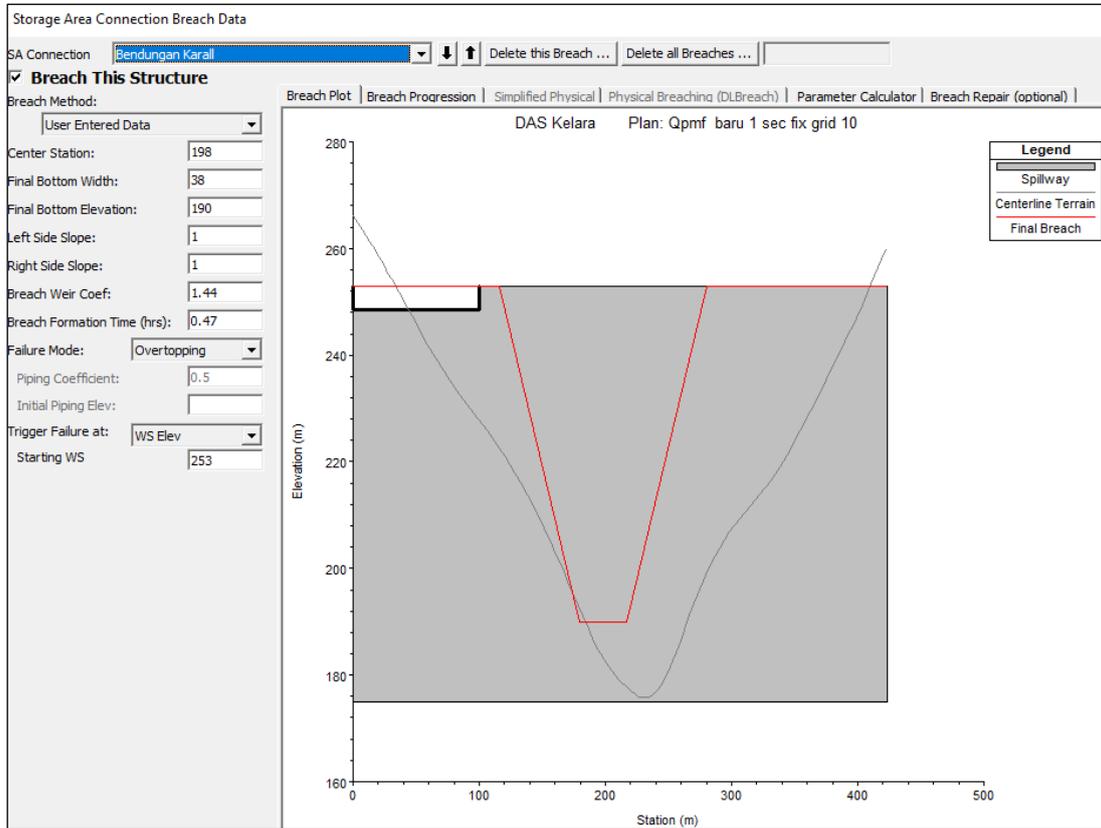
Figure 5. Dam breach parameter plan option is considered a steady Flow

In this study, data are required to support the simulation to run HEC-RAS 6.0.1 and obtain the results of the dam collapse analysis. Figures 5 and 6 show the primary data and scenarios used in general.

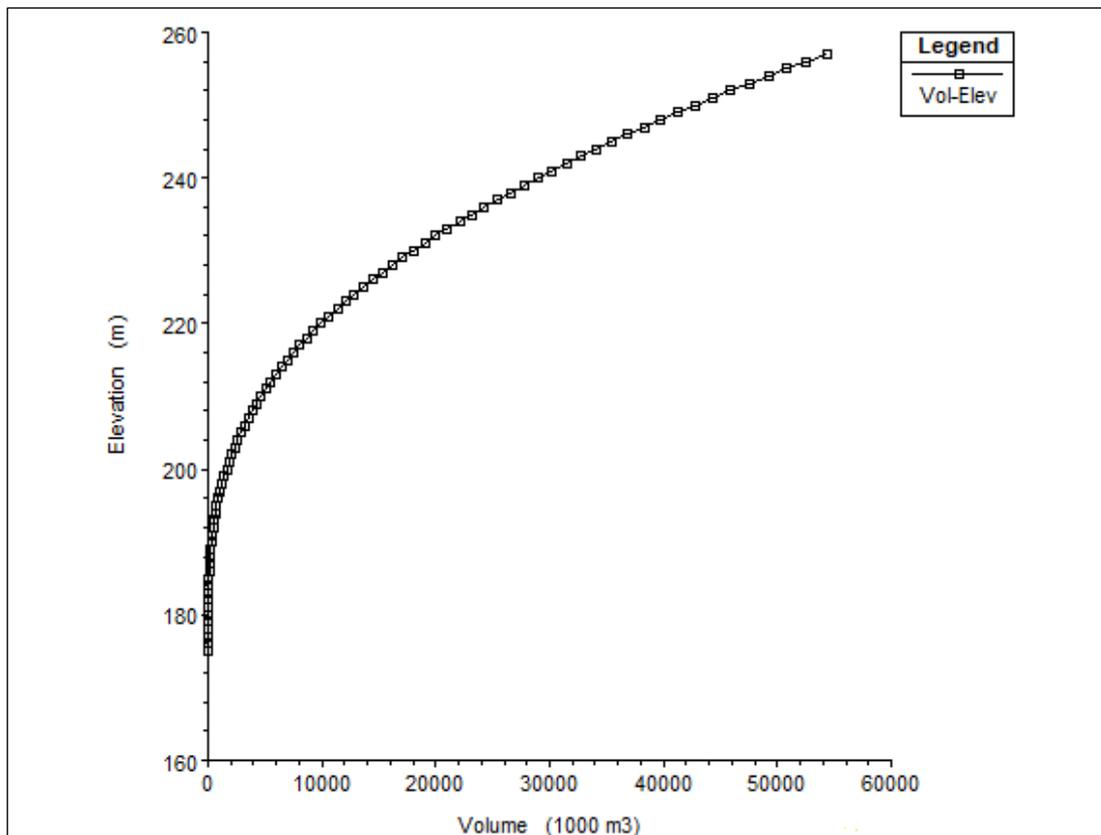
Figure 6. Curve capacity of the Karalloe dam's reservoir

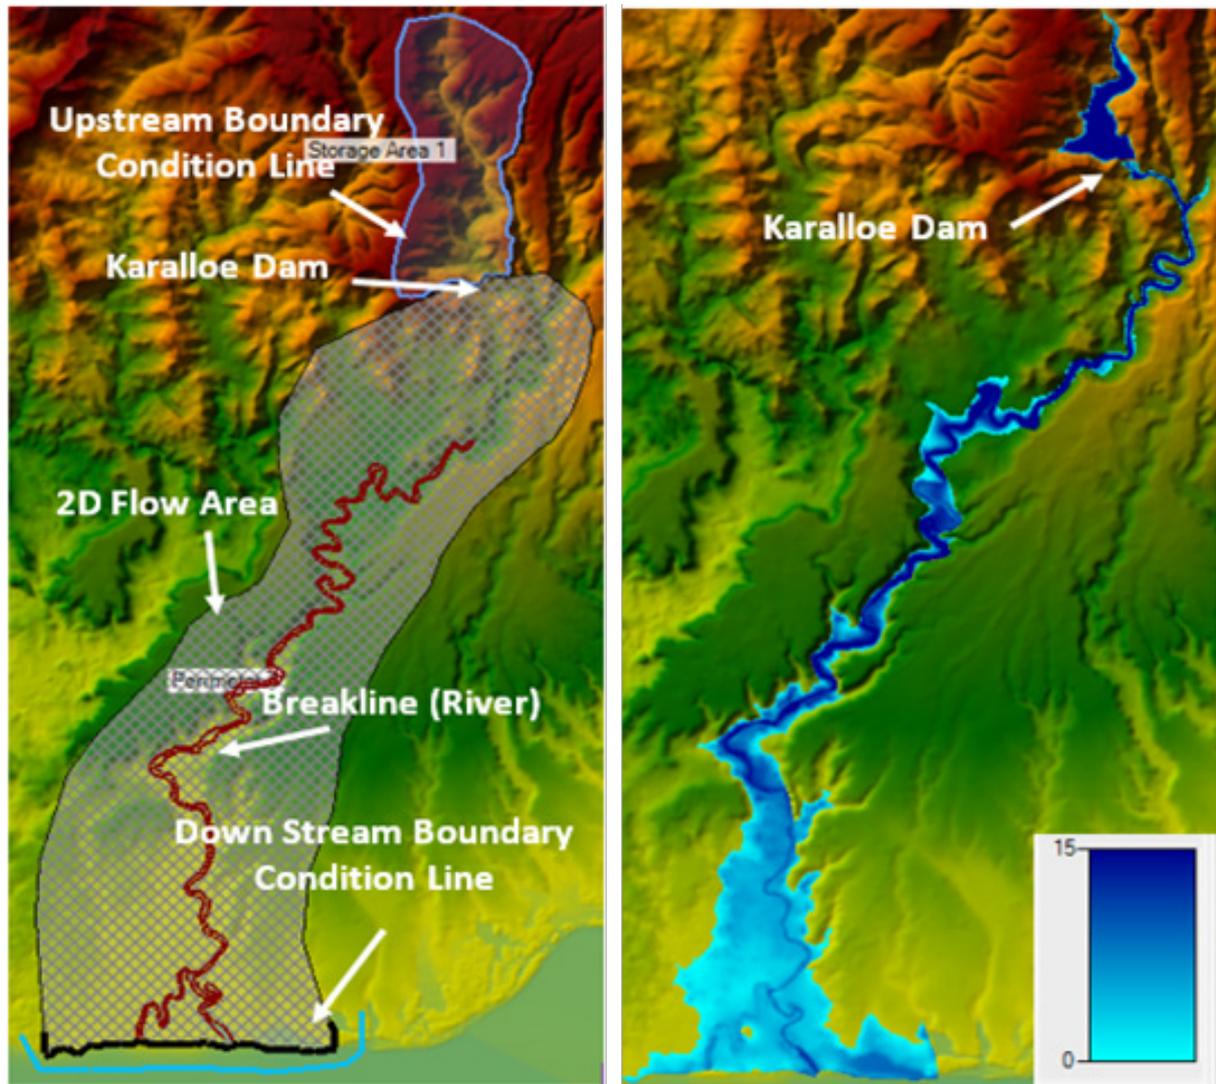
Figure 7. Map of DEM/boundary condition and simulation result of the Karalloe dam's failure

The simulation results of a dam collapse carried out not only produce the distribution of flood inundation but also provide information on the depth at the point to be reviewed, the velocity of the flood flow, and the flood arrival time at a particular location. In general, the flooding visualization due to the collapse of the Karalloe Dam at its top condition can be seen in Figure 7.

The Karalloe dam failure simulation results show that the dam collapsed at 2:28:01 with a QPMF discharge of 3534.8 m<sup>3</sup>/s (simulation time). The floodwater depth level downstream of the Karalloe Dam has decreased as the distance travelled and the time for the flood has increased.

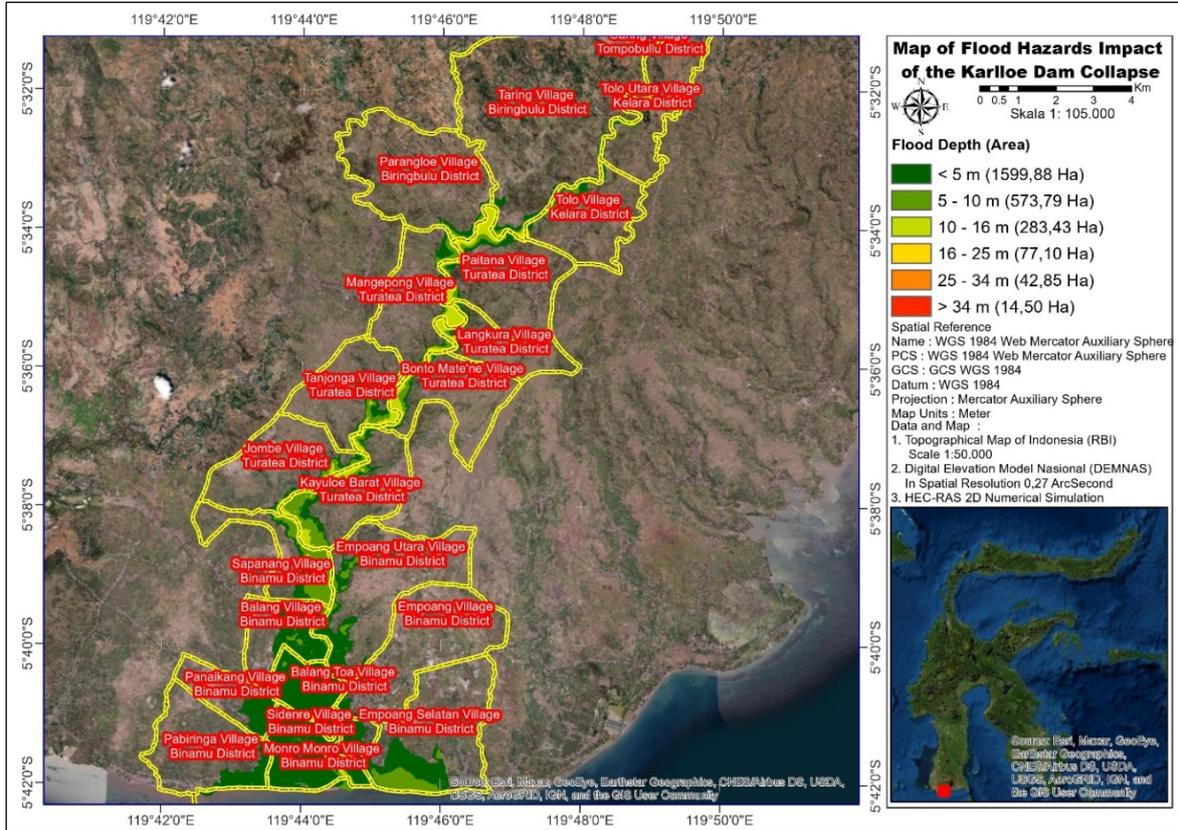
Figure 8. Map of flood hazards due to the collapse of the Karlooe dam

A flood hazard map was created as a reference based on the simulation results of the Karalloe dam's failure to determine the extent of the flood impact caused by the dam's collapse. The flood hazard map is intended to provide information on areas that will be flooded due to a

dam failure. The local government and dam managers can coordinate the notification (warning) process for residents and evacuation procedures for residents who are at risk based on this flood hazard map. Figure 8 depicts the area affected by the collapse of the Karalloe Dam in greater detail.

Figure 8 shows that the collapse of the Karalloe Dam has affected 22 villages from 5 sub-districts. Table 4 shows the affected areas in greater detail. Aside from flood-prone maps, simulation results can also provide information on how long it takes floods to reach each area based on distance and topographical conditions. Monitoring points in densely populated areas must be established to provide information on flood travel times and increase community preparedness in a dam emergency to mitigate the impact of the Karalloe dam's collapse. For more information, see Figure 9 and Table 5. They show flood tracking in the affected areas.

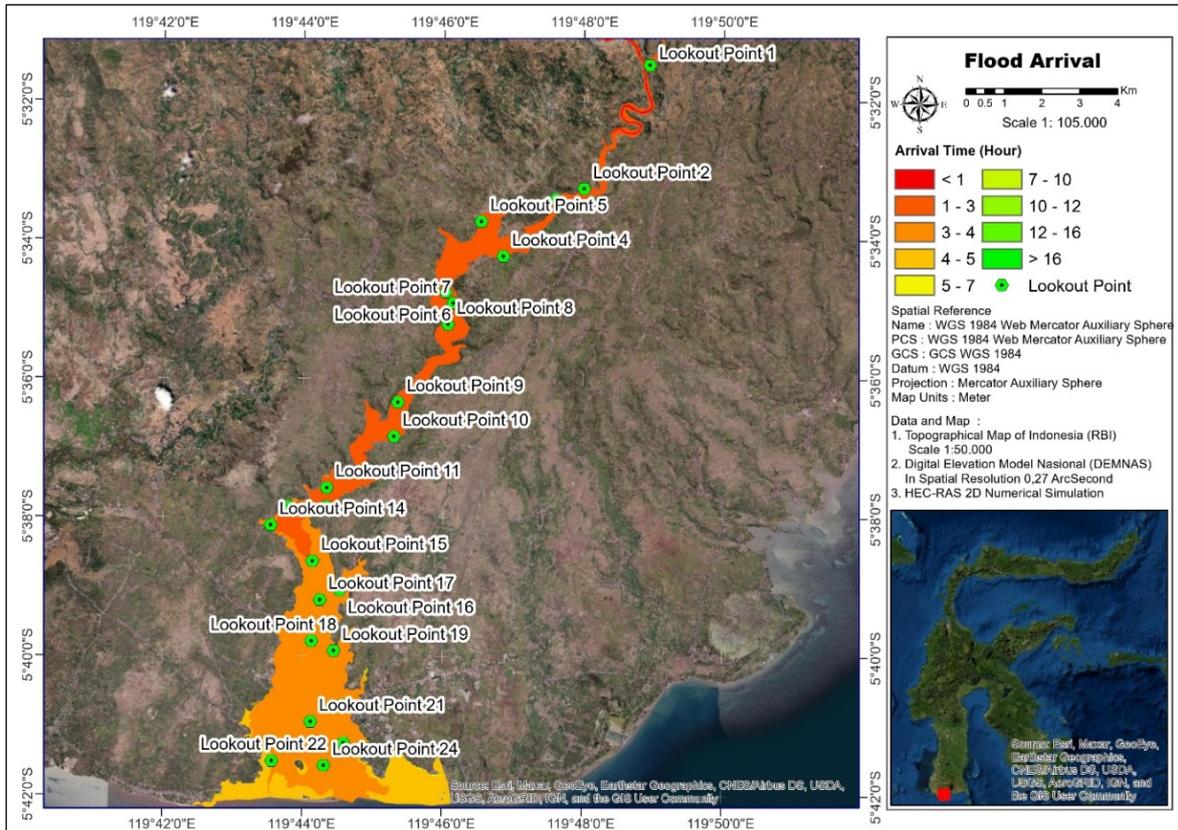
Figure 9. Map of Flood arrival time

12 minutes at Lookout Point 7 in Paitana Village. Furthermore, the longest time is 1 hour and 57 minutes at Lookout Point 22 in Paitana Village. This information is critical for the local government in developing a rescue plan for the people affected by the Karalloe dam failure.
